NATIONAL TRANSPORTATION SAFETY BOARD

TRANSPORTATION SAFETY RECOMMENDATIONS

**ADOPTED DURING THE MONTH
OF OCTOBER, 1998**

1. Report No. NTSB/REC-98/10	2. Government Accession No. PB98-916610	3. Recipient's Catalog No.																			
4. Title and Subtitle Transportation Safety Recommendations - Adopted during the month of September, 1998.		5. Report Date																			
		6. Performing Organization Code																			
7. Author(s)		8. Performing Organization Report No.																			
9. Performing Organization Name and Address National Transportation Safety Board Office of Safety Recommendations Washington, D. C. 20594		10. Work Unit No.																			
		11. Contract or Grant No.																			
		13. Type of Report and Period Covered																			
12. Sponsoring Agency Name and Address NATIONAL TRANSPORTATION SAFETY BOARD Washington, D. C. 20594		14. Sponsoring Agency Code																			
15. Supplementary Notes																					
16. Abstract <p>This publication contains safety recommendations in aviation, marine and pipeline modes of transportation adopted by the National Transportation Safety Board during the month of September, 1998.</p>

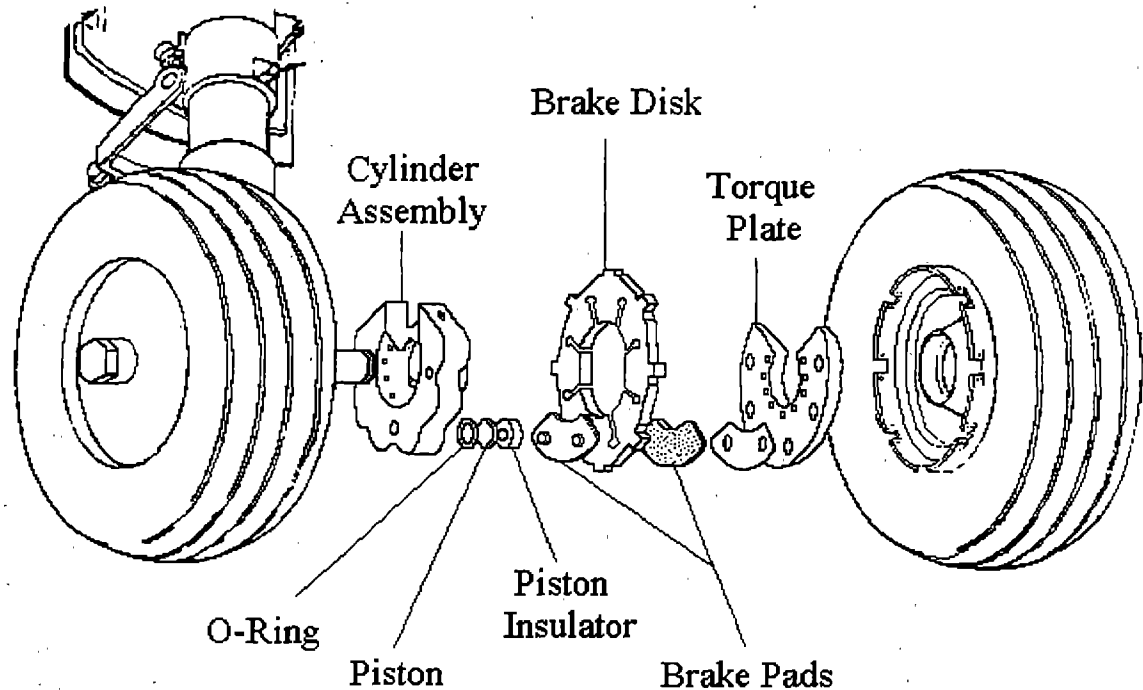
Figure 1. B.F. Goodrich 2-1203 Disk Brake Assembly

hydraulic and fuel lines and fittings, and a burned rubber fuel crossover line. Witness marks on the inside of the brake cylinders and on the outside of the piston insulators indicated that the pistons were cocked within their respective cylinders. Most of the brake pads were worn unevenly, exposing the base metal. The piston insulators and brake disks were also worn unevenly; however, the wear on the disks was within the minimum thickness requirements specified in the airplane's maintenance manual. Although the airplane's main and brake hydraulic systems had a placard specifying MIL-H-83282, analysis of the fluid in both systems revealed a mixture of MIL-H-83282 and MIL-H-5606 hydraulic fluids.⁴ The mixed fluids had a flash point of approximately 237°F.

The investigation thus far indicates that the flightcrew applied the right rudder during the takeoff roll probably to compensate for a dragging left wheel brake and then raised the landing gear, with overheated brakes, into the left wheel well. Although the precise cause of the wheel well fire has not yet been determined, the investigative findings indicate that the ensuing fire in the left wheel well may have been caused by either (1) leaking low flash point brake system hydraulic fluid from a brake cylinder or (2) leaking fluid from damaged lines in the wheel well from an exploding tire coming in contact with and being ignited by the hot brake disk. The fire became hotter as additional flammable liquids from the brake, hydraulic, and fuel systems were introduced. This fire likely led to the wing failure. Leaking brake cylinders could have been caused by the cocked pistons, which appear to have resulted from the combined effects of excessive and uneven brake pad wear, uneven disk wear, and unevenly worn piston insulators on the outboard brake.

The wear measurement techniques specified in the component maintenance manual, SL 1498, and AD 92-01-02 were intended to measure the amount of brake wear. However, the techniques were not designed to measure or detect the degree of uneven wear, which could lead to cocked pistons and result in dragging brakes, hydraulic fluid leakage, and wheel well fires. Therefore, the Safety Board believes that the FAA should require B.F. Goodrich to develop and implement a process for identifying and eliminating excessive uneven wear on all B.F. Goodrich P/N 2-1203 series wheel brake assemblies used on Fairchild/Swearingen SA226 and SA227 series airplanes.

Require B.F. Goodrich to develop and implement a process for identifying and eliminating excessive uneven wear on all B.F. Goodrich part number 2-1203 series wheel brake assemblies used on Fairchild/Swearingen SA226 and SA227 series airplanes. (A-98-114)
